Manhole Inspection Summary

Manhole # S21A__047MH

Insp Date: **9/14/07 10:38 AM**

Location Address: **1600 HARLEM ST**

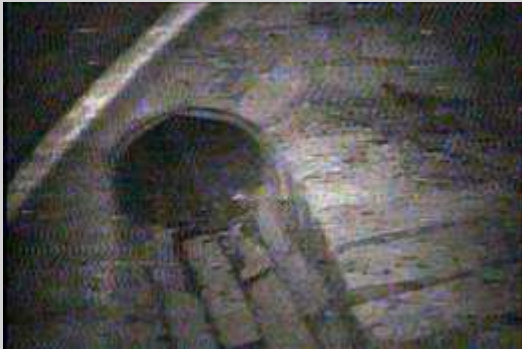
12 O'Clock Outflow

8 in. Circular Gravity Sewer
Pipe Out @ 12 O'Clock

Pipe Height: **8.4** (in.) Rod and Bar (Angled)
Pipe Material: **Clay** ☐ Pipe Lined
Invert Depth: **8.62** (ft.) Flow Characteristics: **Slow**
Deposits: ☒ None ☐ Mud ☐ Sludge ☐ **Debris** ☐ Grease
Silt Depth: (in.) Deposits Extent:
Infiltration: **None** Pipe Seal Cond: **Sound**
